NATIONAL DAM SAFETY PROGRAM. SOUTH RIVER NUMBER 6 (ID VA-01509)--ETC(U)

Name of Dam: South River No. 6

Inventory Number: VA 01509

PHASE I INSPECTION REPORT
NATIONAL DAM SAFETY PROGRAM

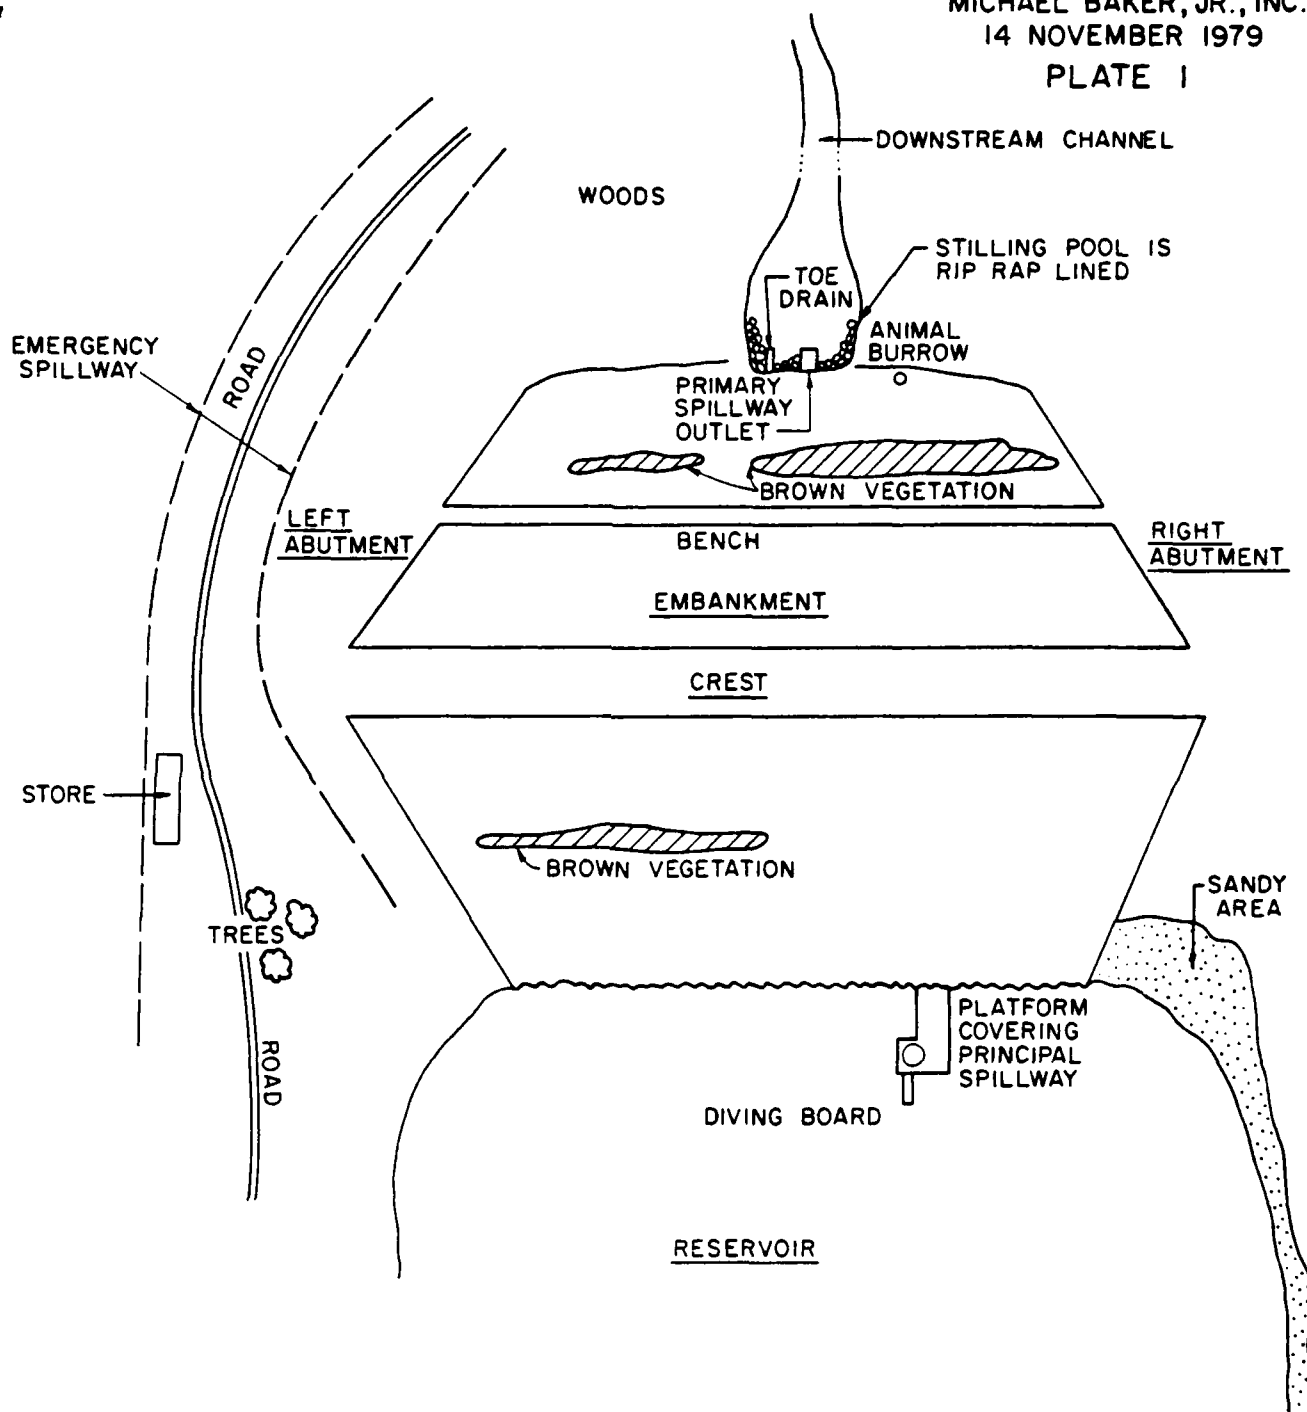
PLATE I

NOTE:
BENCH ON DOWNSTREAM EMBANKMENT TILTS BACK TOWARD THE EMBANKMENT —
STANDING WATER PRESENT IN TROUGH ON BENCH
MANY MOLE BURROWS / TRACKS PRESENT ON DAM

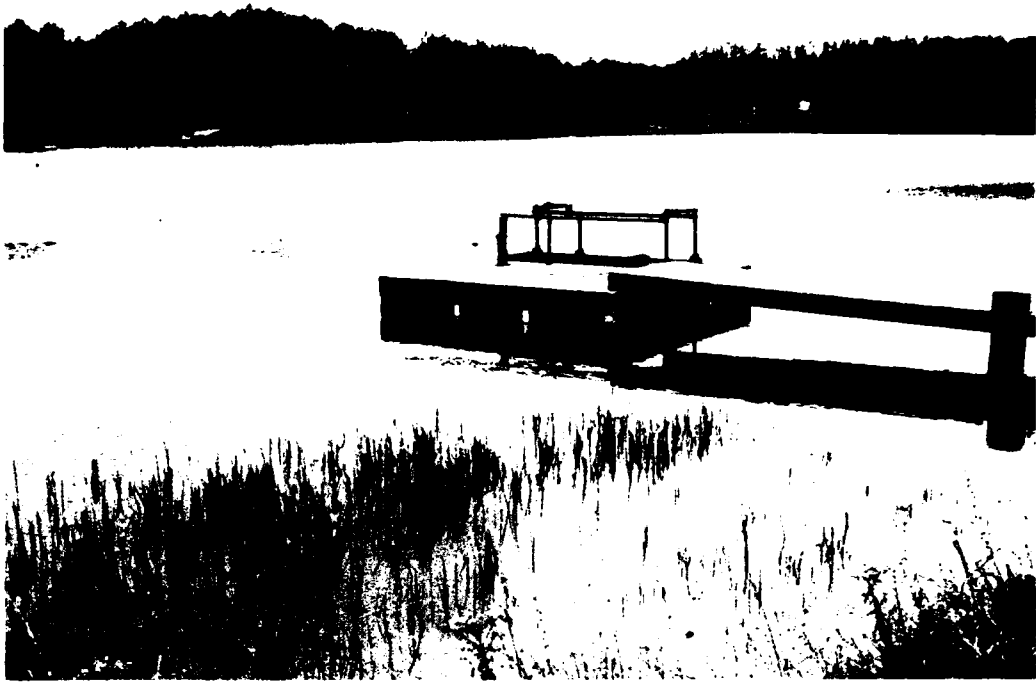
PHOTO 1. Principal Spillway Riser with Lift Pedestal for Reservoir Drain

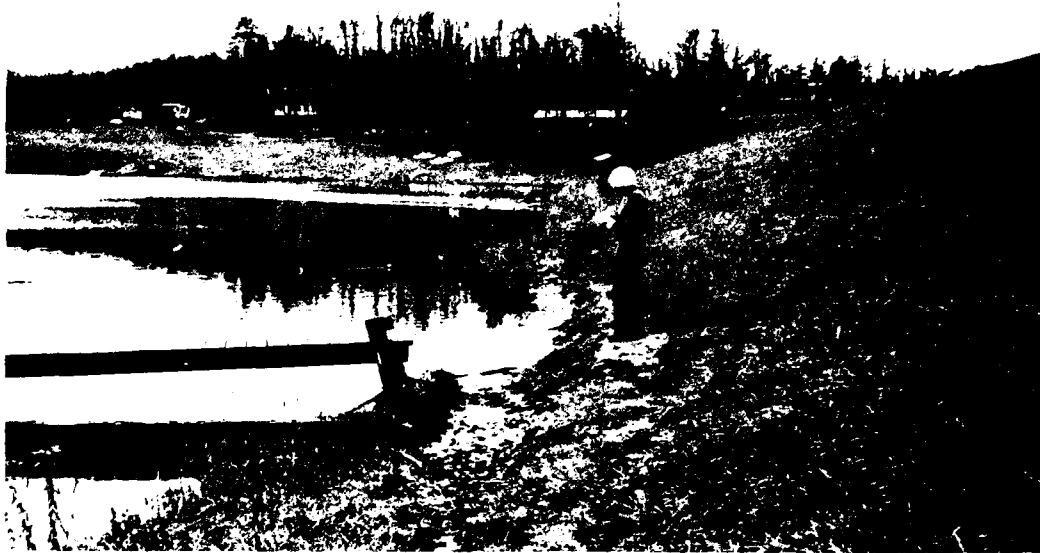
**PHOTO 3. Emergency Spillway Approach Channel (Background) and
Small Erosion Berm Forming at Waters Edge**

3.2 Evaluation: In general, the dam and appurtenant structures are in good condition. Seeding is recommended for the brown and dormant vegetation areas. The animal burrow should be filled. The berm on the upstream face should be observed during annual inspections and riprap should be installed if erosion continues.

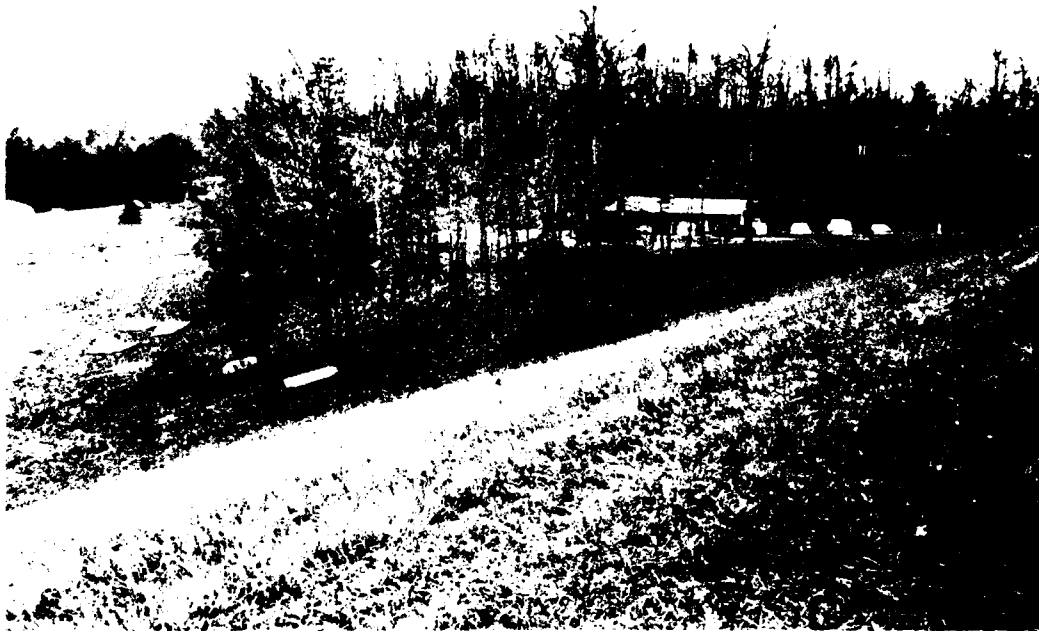
**PHOTO 4. Location of Office/Store in the Emergency Spillway
Approach Channel**

VISUAL EXAMINATION OF	OBSERVATIONS	REMARKS OR RECOMMENDATIONS
CONCRETE WEIR	None	
APPROACH CHANNEL	<p>The campground office and store is located in the approach channel. The entrance road to the campground is located in the spillway. Other than the office and store, there are no major obstructions in the approach channel. The channel is well vegetated with grass and is mowed regularly.</p>	<p>The SCS and the conservation district have both advised the owner that he may not make any additions to the building in the spillway, and warned him that he will lose the building if a major flood occurs. The building should be removed because it restricts flow through the spillway. The building was constructed by the previous owner of the dam.</p>
DISCHARGE CHANNEL	<p>There are no major obstructions in the discharge channel. The discharge channel is well vegetated with grass and is mowed regularly.</p>
